**[Docket No. FAA-2018-0454; Product Identifier 2017-NM-056-AD;  
Amendment 39-19387; AD 2018-18-08]**

**Airworthiness Directives; Airbus SAS Airplanes**

**ACTION:** Final rule.

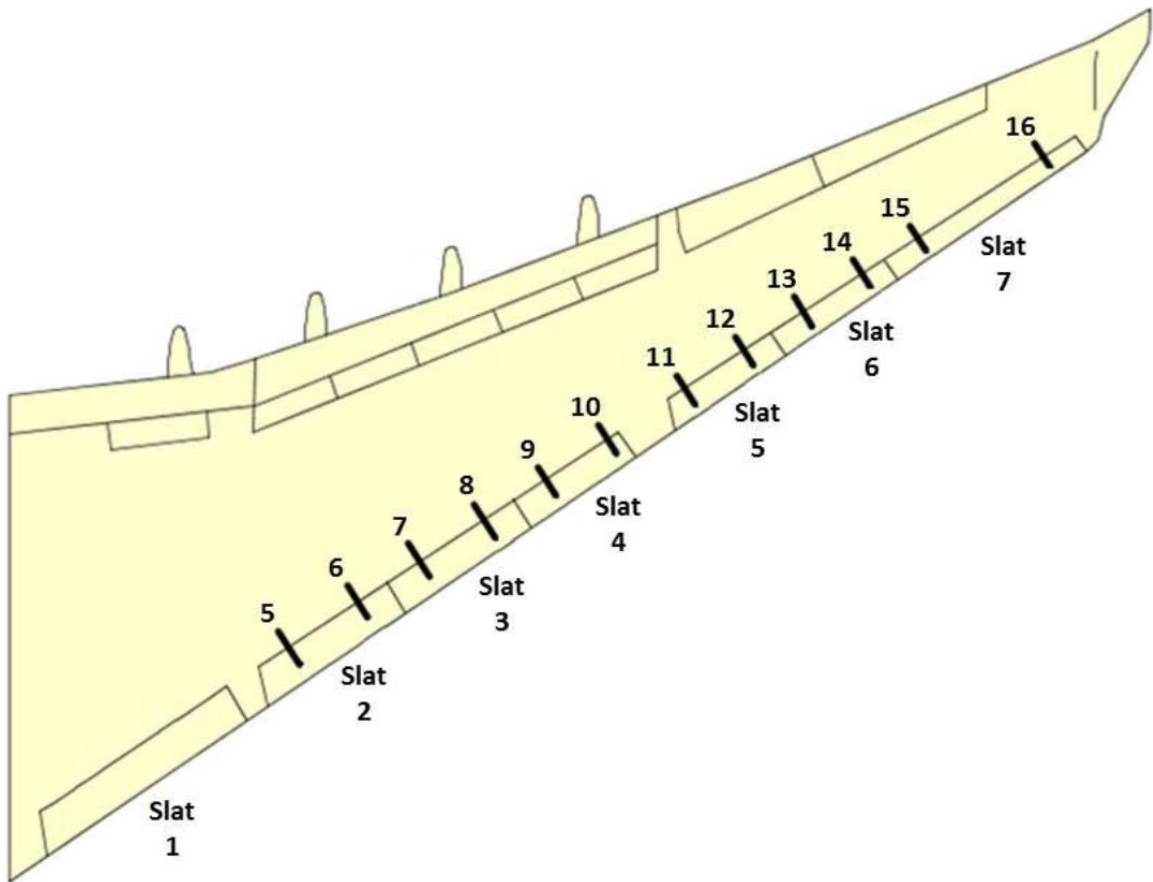
**Figure 1 to paragraph (g) of this AD – Positions of Affected Slat Tracks**

(1) For the purpose of this AD, “affected slat track” is defined as a pre-modification 45967 slat track, located at the wing positions as indicated in figure 1 to paragraph (g) of this AD, and having a part number specified in figure 2 to paragraph (g) of this AD. In case the part number identification (ID) plate is missing or cannot be read, the slat track can be identified by the ink marking. If the operator cannot determine the part number, then that airplane is in Group 1.
